Preserving the substance and significance of gravestones

CONDITIONS SUMMARY,
CONSERVATION RECOMMENDATIONS
AND
CONDITION ASSESSMENTS

OLD BURYING GROUND
STONEHAM, MA

April 2012

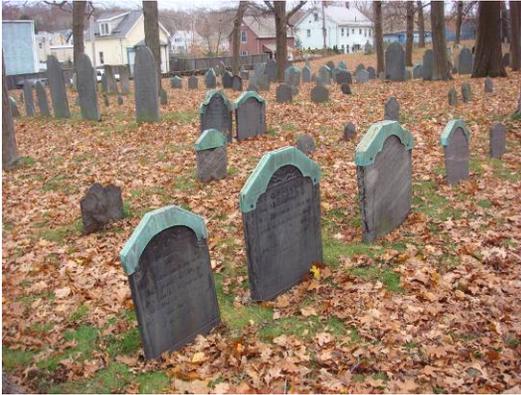
*Caps in Old Burying Ground
Stoneham*

Unfortunately the caps in the Old Burying Ground (which started in the late 1930's and continued up until 1950) are held on by bolts drilled through the stone. In many cases the caps obscure and deface the original carving. Aesthetically they diminish the overall quality of the cemetery.

There are 64 slate markers that are "capped" in this way and otherwise appear to be stable. Because the capping was completed over 50 years ago, and can therefore be considered somewhat "historic", we recommend that representative examples of 5 to 7 caps remain and all the other caps removed. This sampling can be decided by the Stoneham Cemetery Commission. The condition of the slates can then be fully assessed, mounting holes can be properly filled and any voids caused by delaminations can be addressed.

While the capped markers do not exhibit "ongoing deterioration", we recommend the removal of the caps, filling of mounting holes and additional treatment when required (see "Filling of delaminations"- Page 15)

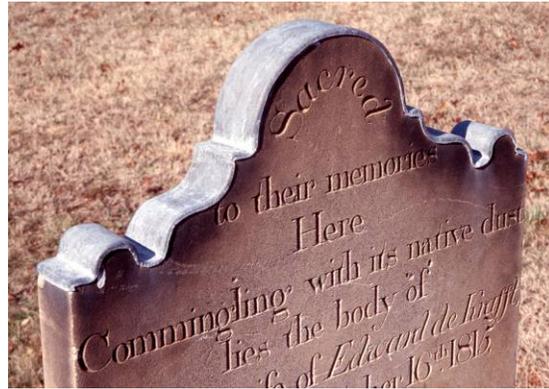
There are a great number of slates which have been "capped" with copper or metal coverings. These caps were meant to help prevent water from entering through small cracks and delaminations which are typically found in slates (and sandstones). Limiting the accumulation of water during freezing temperatures would thus reduce future expansion and ongoing deterioration of the stone. This was often tastefully done in the late 19th and early 20th century with thin strips of lead or copper. These early examples have now become a historical part of a cemetery.

*Example of a historical lead cap
Hartford, CT*

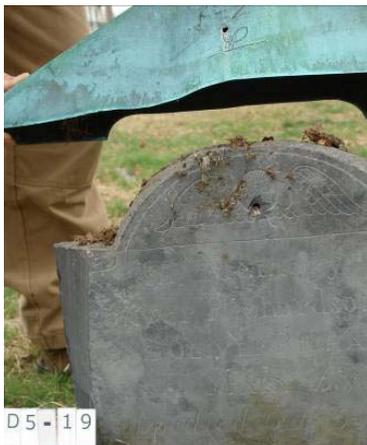
*Original carving covered
and hole drilled through
angel motif (Oliver Richardson)*

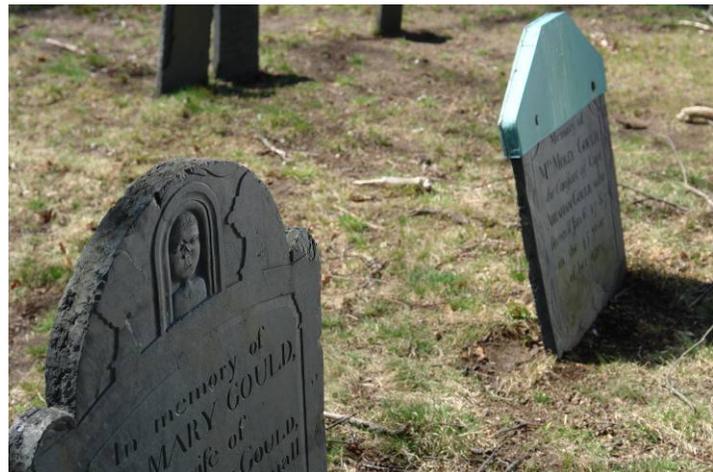
Example of covering original carving

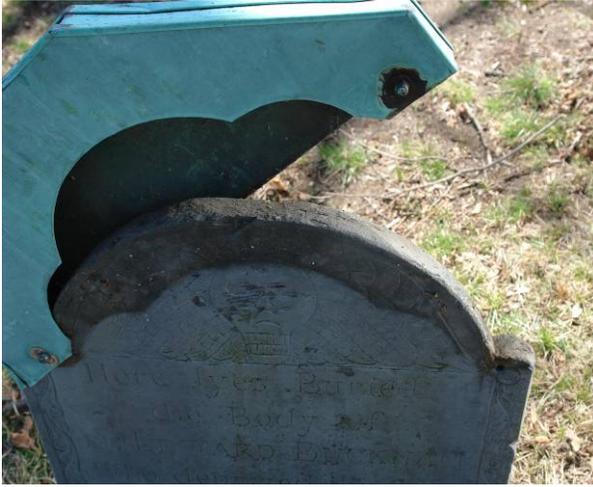
In a few cases where the bolts were loose we were able to tilt "open" the cap and note the condition of the stone.

There are no visible delaminations of this marker (Edward Bucknam)

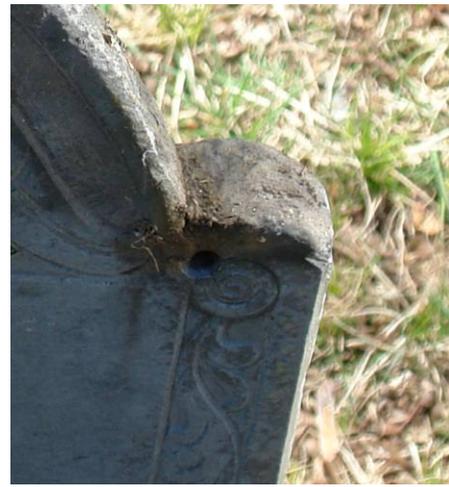
Detail of hole

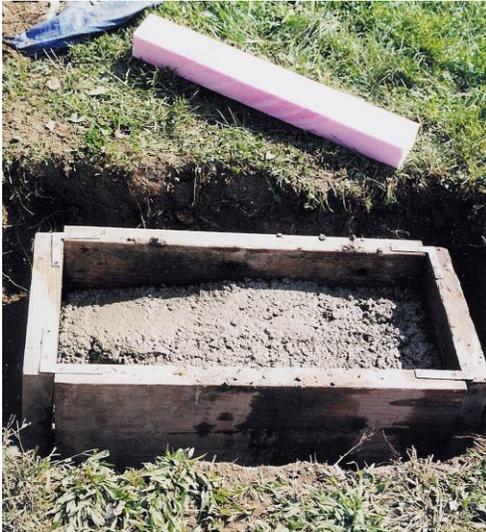
The bases are minimally 12 inches deep, 12 inches greater in thickness and 6 inches wider than the stone itself. Once the concrete has cured, forms are removed and the stones are reset into the slot as above.

On left, a new base partially filled with concrete and foam setting form in background.

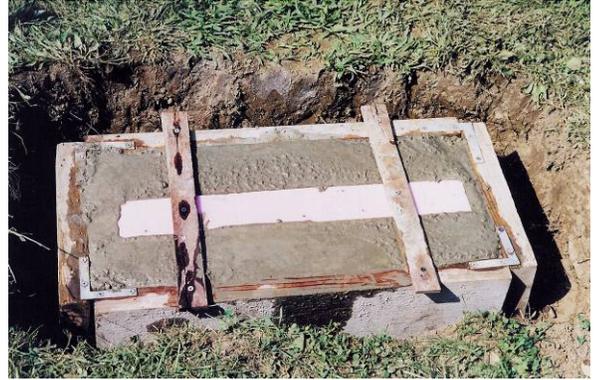
Above, the poured base with setting form in place

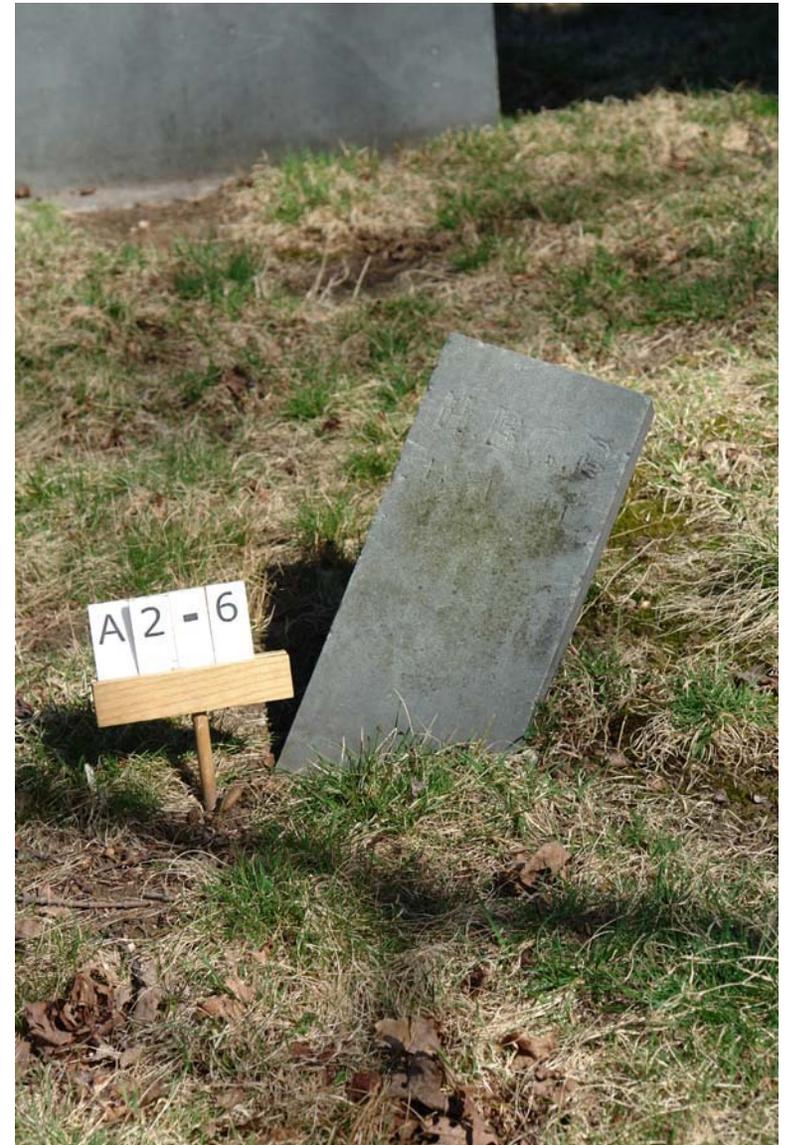
Exist # **77.1**

Condition of Inscription: **decipherable**

EXISTING CONDITIONS	CONSERVATION STRATEGY
Tilted	Reset

CONSERVATION PRIORITY 3 1) Hazardous, immediate action 2) Unstable- asap
3) Ongoing deterioration, treat 2-5 years 4) Stable
A) Artistic H) Historical P) Visually prominent M) Monitor

RECOMMENDED TREATMENT
<ol style="list-style-type: none">1. Excavate footstone; remove soil from setting area to appropriate depth.2. Remove soiling by light brushing with nylon brushes and water3. Re-set footstone plumb at appropriate height and level onto gravel bed, aligned with adjacent markers4. Backfill area around footstone with tamped sand and gravel5. Re-grade disturbed areas with existing topsoil.

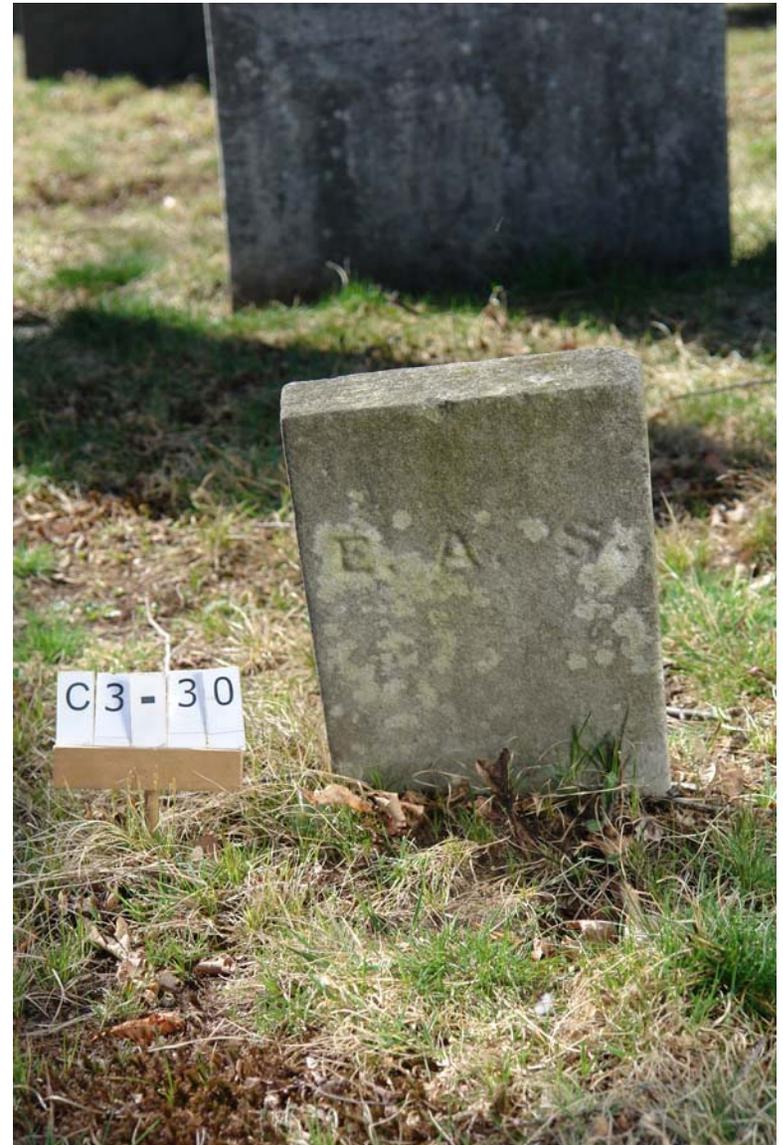
Exist # **118.1**

Condition of Inscription: **Legible**

EXISTING CONDITIONS	CONSERVATION STRATEGY
Tilted	Reset

RECOMMENDED TREATMENT
<ol style="list-style-type: none"> 1. Excavate footstone; remove soil from setting area to appropriate depth. 2. Remove soiling by light brushing with nylon brushes and water 3. Re-set footstone plumb at appropriate height and level onto gravel bed, aligned with adjacent markers 4. Backfill area around footstone with tamped sand and gravel 5. Re-grade disturbed areas with existing topsoil.

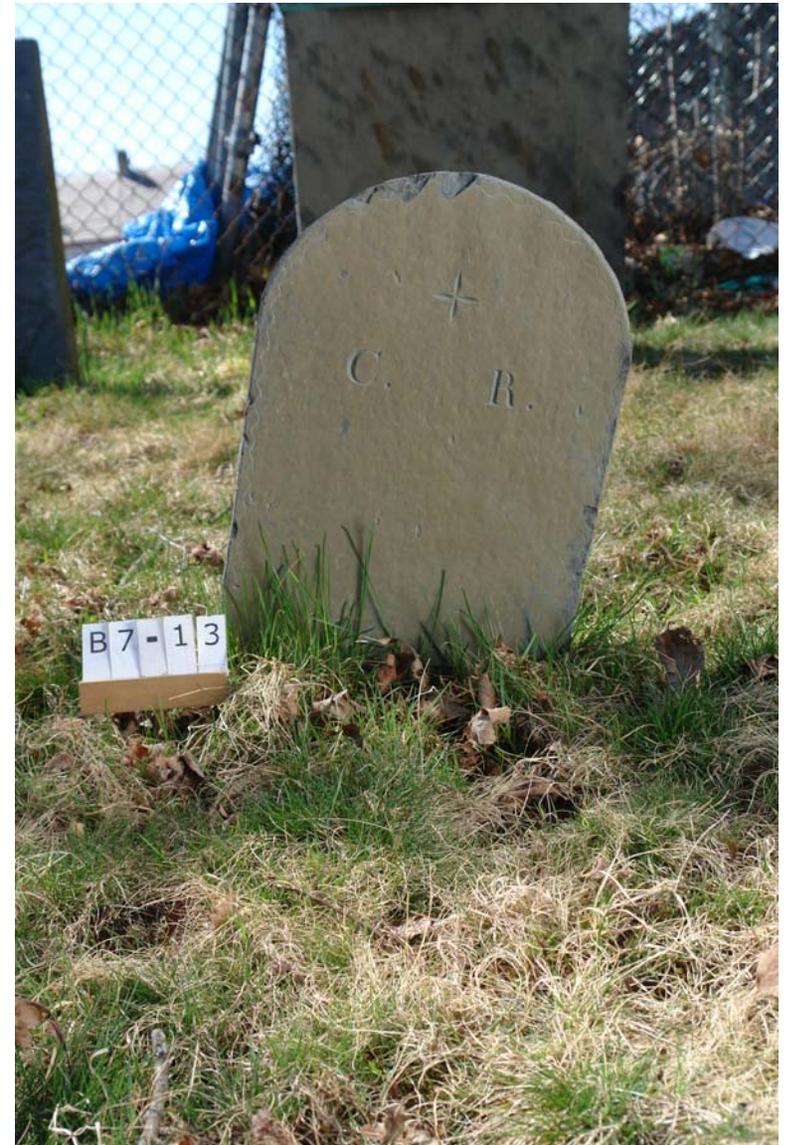
Exist # **230.1**

Condition of Inscription: **Legible**

EXISTING CONDITIONS	CONSERVATION STRATEGY
Tilted	Reset

RECOMMENDED TREATMENT
<ol style="list-style-type: none"> 1. Excavate footstone; remove soil from setting area to appropriate depth. 2. Remove soiling by light brushing with nylon brushes and water 3. Re-set footstone plumb at appropriate height and level onto gravel bed, aligned with adjacent markers 4. Backfill area around footstone with tamped sand and gravel 5. Re-grade disturbed areas with existing topsoil.
